# Volume IV Appendix F.5

## Space Shuttle STS-107 Columbia Accident Investigation, External Tank Working Group Final Report – Volume 1

This report summarizes the results of the analysis, design, production, and performance of External Tank (ET-93), performed by the External Tank (ET) Working Group (ETWG), as part of the STS-107 *Columbia* Accident Investigation.

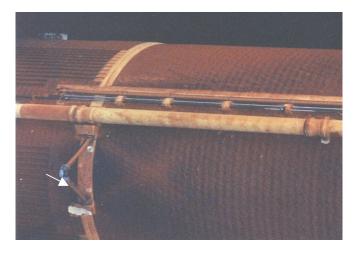
Figure 5.3.3.2-2. STS-50/ET-50

The TPS loss event on STS-50/ET-50 encompassed the majority of the bipod ramp, measuring 26 in. x 10 in. and weighing 0.98 lb (Figure 5.3.3.2-2). This loss was attributed to voids/debonds in the Isochem bond layer of the non-vented two-tone TPS area. ET-50 was the last ET built with this intertank TPS configuration.

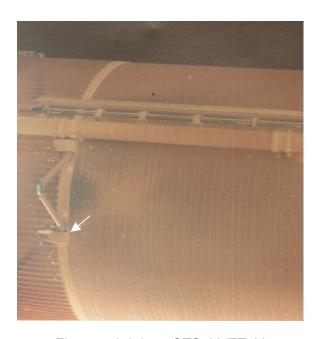
Figure 5.3.3.2-4. STS-62/ET-62

On STS-62/ET-62, there was a small divot in the aft face of the ramp measuring approximately 3 in. x 1 in. and weighing 0.001 lb. (Figure 5.3.3.2-4)

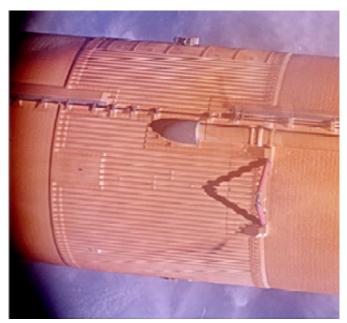
Figure 5.3.3.2-5. STS-112/ET-115

On STS-112/ET-11, the TPS loss location and shape was similar to that observed on STS-52 (Figure 5.3.3.2-5). The TPS loss on STS-112 was estimated to be 7 in. x 12 in. with a mass of 0.3 lb.
